From: Bill Willis- TWU 555 LAS Safety Chairman

Date: March 12, 2015

Subject: Seattle Station Visit Equipment Report

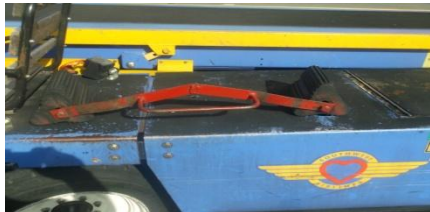
Heavy metal wheel chock holders on all station belt loaders will be replaced with rope and anchor to each belt loader in the near future. Fred Susoeff agreed to this and will direct local ground maintenance contractor to do so.
