TWU 555 Safety & Health Committee

To: Jesse Soto, Safety & Health Advisor
From: Rudy Del Real, Safety & Health Committee
Date: September 8, 2015
Subject: DEN Provo Safety Visit

Provisioning Facility

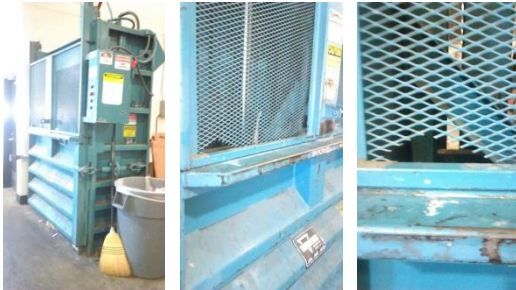
- I recommend that Provo leadership order a dishwasher unit and have it installed under the three-compartment sink counter.
- When Dina inspected the Porta Gator she found that it was missing the tray, broom shovel and that it also needed absorbent.
- Outside of the ice room we found standing water on the warehouse floor, this is a slip hazard.
- Provo agents report that the bale indicator light on the cardboard baler is inops.
- Gloves should be available at the cardboard baler.
- The metal mesh on cardboard baler gate is damaged the gate should be replaced or repaired.

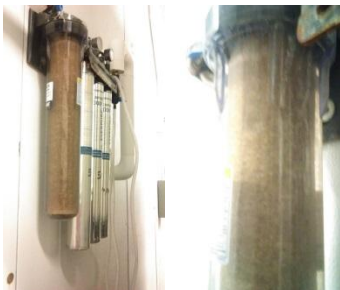
- The last cleaning and sanitizing of the ice machines/ice bins is unknown – not documented, no service logs could be found in the ice room or in the ice machine room.
- The ice machine **Pre-filter** EC210 cartridge should be replaced when dirt has penetrated to the inner core of the cartridge. The Pre-filter for ice machine 1 and 2 are extremely dirty and must be replaced.

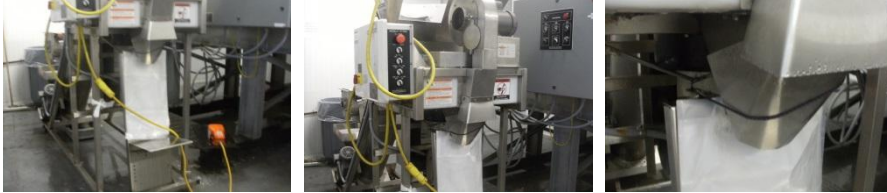
- Ice bags have to be stored in a sanitary manner, I found ice bags laying on the ice freezer floor

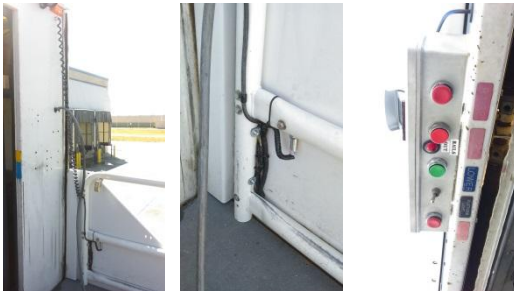
Provisioning Truck 19

- A new safety mechanism has been installed on the guard rails. If the guard rails are not fully retracted the safety mechanism will prevent the box from being lowered. A light indicator has also been installed on the raise/lower control box.

- The hand sanitizer wall dispenser unit located in the box needs to be filled
- The Blood Borne Pathogen Incident/Exposure Quick Reference Guide needs to be posted in the box.
- The service engine soon light was on at the time of inspection.
- The truck needs a longer tape switch sensor on the passenger side of the platform.
- When the platform tape switch makes contact the box lowers and the alarm should beep, at the time of inspection the alarm was inop.
- The box interior needs to be power washed.

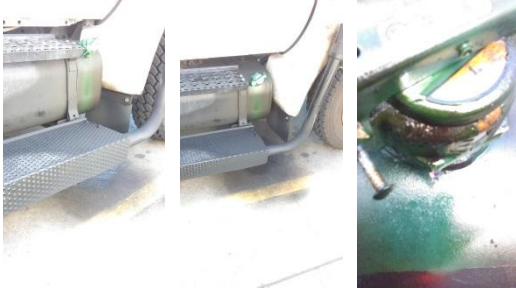
Provisioning Truck 2

- At the time of inspection fuel was dripping from the fuel cap onto passenger step and ground. This serious safety concern was addressed with DEN GSE Leadership, the majority of the Provo trucks I inspected were leaking fuel from the cap and the ground was wet from the leaking fuel.
