To: Jesse Soto, Safety & Health Advisor  
From: Dina Enders, Safety & Health Committee  
Date: March 3, 2015  
Subject: OAK Safety Visit

### **T-POINT**

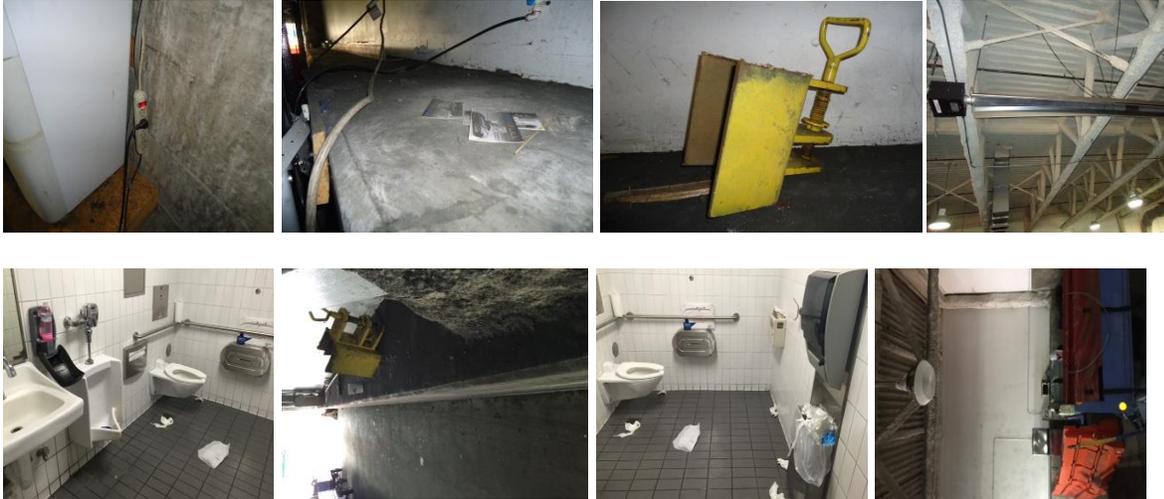
1. This area is filthy and not just covered with trash. I am talking about dust, soot and cob webs. These health hazards cover the wall, computer, monitor, equipment and the floors. Ramp Sups and Ramp Agents have the same complaints about the condition of T-point. Our employees are affected internally with every breathe they take. **OSHA 29 CFR 1910.141**

2. T-point area must be power washed, last time t-point was washed was 7 months ago.
3. Air quality is bad because each morning as aircraft are pushed off the gates aircraft tail faces directly into the t-point area blowing in exhaust and jet fumes. Employees working at t-point have been asking for a resolution. The exhaust is from all aircraft not just Southwest but all airlines straight into our work area.

6. Air filters above the employees work area need to be cleaned.
7. Exit sign is inoperable. **OSHA 29 CFR 1910.38**
8. Heaters above the work area are inoperable so they do not provide heat.

9. Bird nets need to be installed inside above the baggage carts to prevent birds from nesting and bird droppings on employees and customer bags. **OSHA 29 CFR 1910.141**

10. Anti-Fatigue mats around the belt have areas that are sticking up creating a trip hazard. **OSHA 29 CFR 1910.22**
11. The pavement by the t-point belt is uneven. This creates a trip/fall hazard. Agents expressed concerns over the complication this rise in pavement can cause when trying to move a cart into and out of the area. **OSHA 29 CFR 1910.22**

12. Southwest, TSA, Skycap and Customer Service use these bathrooms. The bathrooms are nasty and need to be cleaned. **OSHA 29 CFR 1910.141**
13. Extension cords are improperly used at t-point. **OSHA 29 CFR 1910.305**

14. FOD trash cans are overflowing. **OSHA 29 CFR 1910.141**
15. First Aid Kit needs to be restocked. **OSHA 29 CFR 1910.151**
16. FID Screen/Monitors at t-point are hard to read.

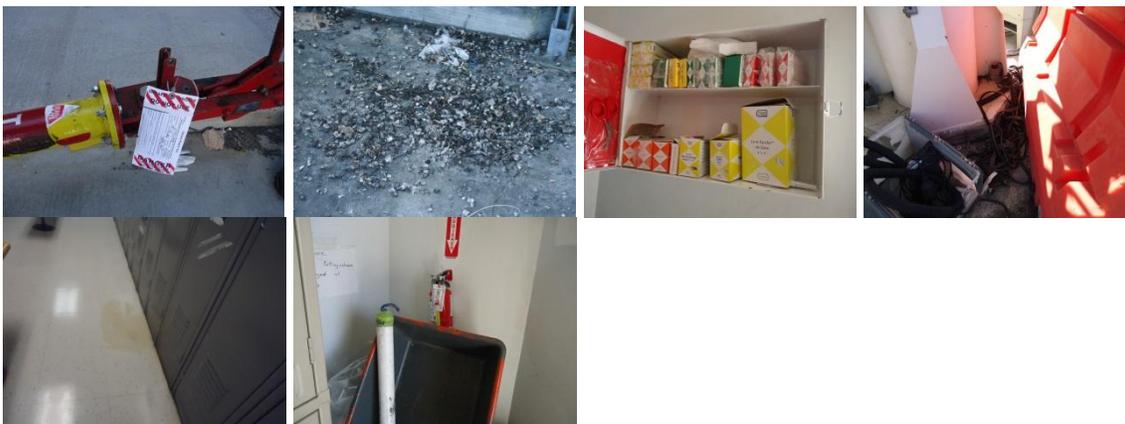
1. The Port of Oakland Port requires two wing walkers for each aircraft. Local management is using 2 wing walkers on mid-morning flights but not on originators or terminators. OAK is also in need of an adequate number of wireless headsets to use two wing walkers.

4. New policy and procedures are not being talked about prior to going into effect. **Remains an Open Item.**
5. Bird droppings all over the ground on the ramp by T-27. **Remains an Open Item.**

6. Tow bar procedures –what to do when the shear bolt breaks, this Tow bar was Tag out of Service on 3-1-2015. The bolts were still on the ground during my visit. **Remains an Open Item.**

9. Men locker room behind T27 was flooded prior to my visit from the upstairs bathroom.
10. Fire Extinguisher in Ramp Sups office is blocked by trash and bins. **OSHA 29 CFR 1910.157**
