## **TWU 555 Safety & Health Committee**

To: Jesse Soto, Safety & Health Advisor  
From: Rudy Del Real, Safety & Health Committee  
Date: June 23, 2015  
Subject: PVD Safety Visit

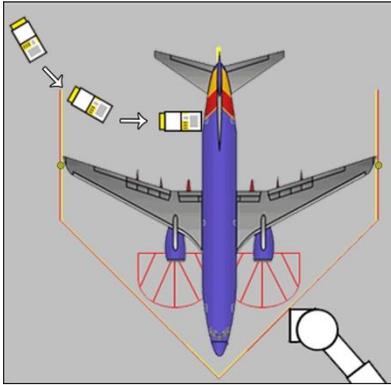
**Figure 5.56 Approach from # 2 side**

*The GOM 5.26.2 has pictures illustrating the Provisioning Van approaching an aircraft from the number 2 side (Figure 5.56) and the number 1 side (Figure 5.55) of the aircraft.*

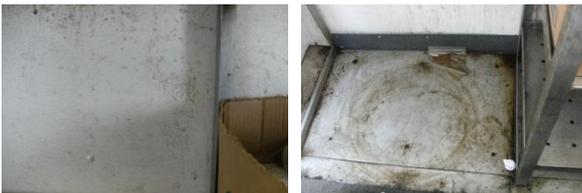
- The Provo Van needs a camera system installed
- The curtain rod needs some type of lubricant applied
- The van needs two platform underside round mirrors installed
- The rear curtain is missing the additional latch clip
- The fire extinguisher located at the rear of the box was last checked on 3/10/15
- The fire extinguisher located by the cab is missing

- The van has rear step damage
- The van needs a suction pump wand holder
- The spot light located by the platform control panel has a torn wire

- PVD Leadership must implement and maintain a Provisioning Van cleaning program. The interior of the box needs to be power washed.

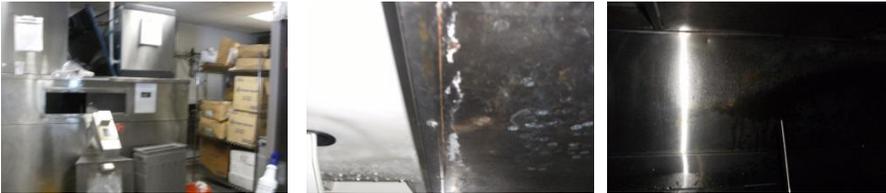
I found rust and calcium build up in the interior of the ice bin. On the day of my visit Miguel Sierra from GL Facility Services was servicing the ice machine and ice bin. Rust was still found on the interior of the ice bin and the interior top of the ice bin after GL Facility Services departed for the day. The ice machine should remain out of service until the ice bin has been cleaned and is rust free.

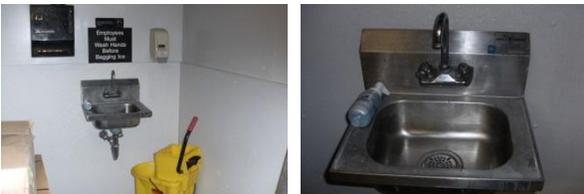
Boxes containing ice bags were laying on the ice room floor. Ice bags have to be stored in a sanitary manner.

The paper towel dispenser located in the ice room needs to be filled and the sink needs to be cleaned.
