TWU 555 Safety & Health Committee

To: Jesse Soto, Safety & Health Advisor
From: Dina Enders, Safety & Health Committee
Date: 22 September 2015
Subject: PHX Operations Safety Visit

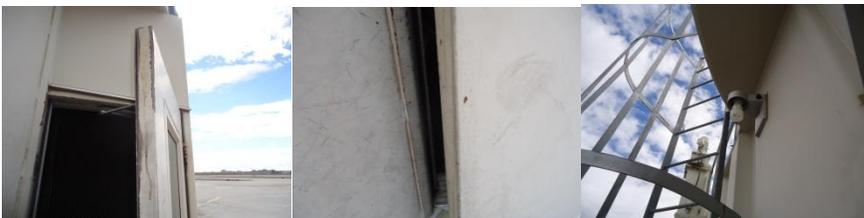
GATE D-6

1. Missing canopy pad located on the outside of the jet way next to where aircraft parks.
2. The jet way door is sticking on the door frame and will not completely shut and is difficult to open.
3. The hinge on the uneven surface is loose and there are several screws missing.
4. The warning beacon light is not working while backing up from aircraft.
5. The SDS sticker is missing on the telephone inside the jet way.
6. Alignment line for the aircraft has several different markings on the jet way rubber bumper.

7. Door hinge is broken going down to aircraft.
8. Safety Railing bolts is missing making the handrail unstable.
9. Roll up door bottom rubber bumper is damaged.
10. Light fixture cover is missing.
