To: Jesse Soto, Safety & Health Advisor
From: Dina Enders, Safety & Health Committee
Date: 16 September 2015
Subject: SEA Safety Visit

Jesse, I made a visit to SEA to do a complete Ramp Walk requested by the Local Membership. I was accompanied by Local Rep Shawn Ufer.

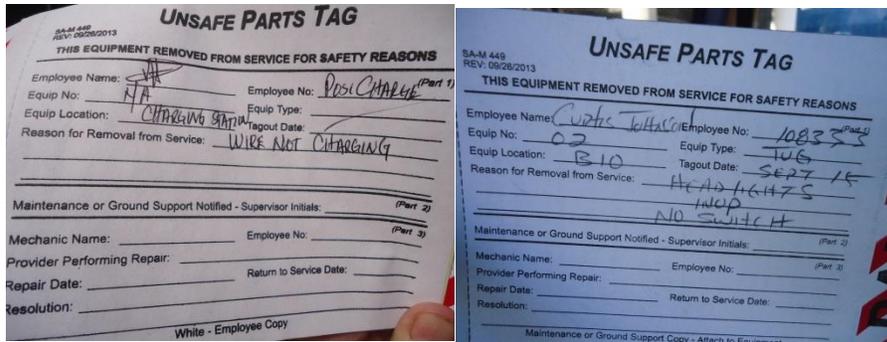
UNSAFE PARTS TAG

- A. Ramp Supervisor filled these out with all copies still attached! Part 2 and 3 are not being done here in SEA, GSE contractor does not fill out Part 3 and there is no resolution for the equipment.
- B. Being proactive instead of reactive protects our Employee's, our Customers, Aircrafts and Equipment.
- C. The Employees are the Operator of Equipment being used during that time. SEA has a memo that states that any equipment being Tag out of Service you first must contact Ramp Supervisor who will then deem if the piece of equipment in question is safe or be Tag out by Ramp Supervisor only.
- D. Ramp Supervisor isn't the one using the equipment, the Employee working the flight is responsible for checking the Operator's Daily Checklist. **OSHA 29 CFR 1910.178**

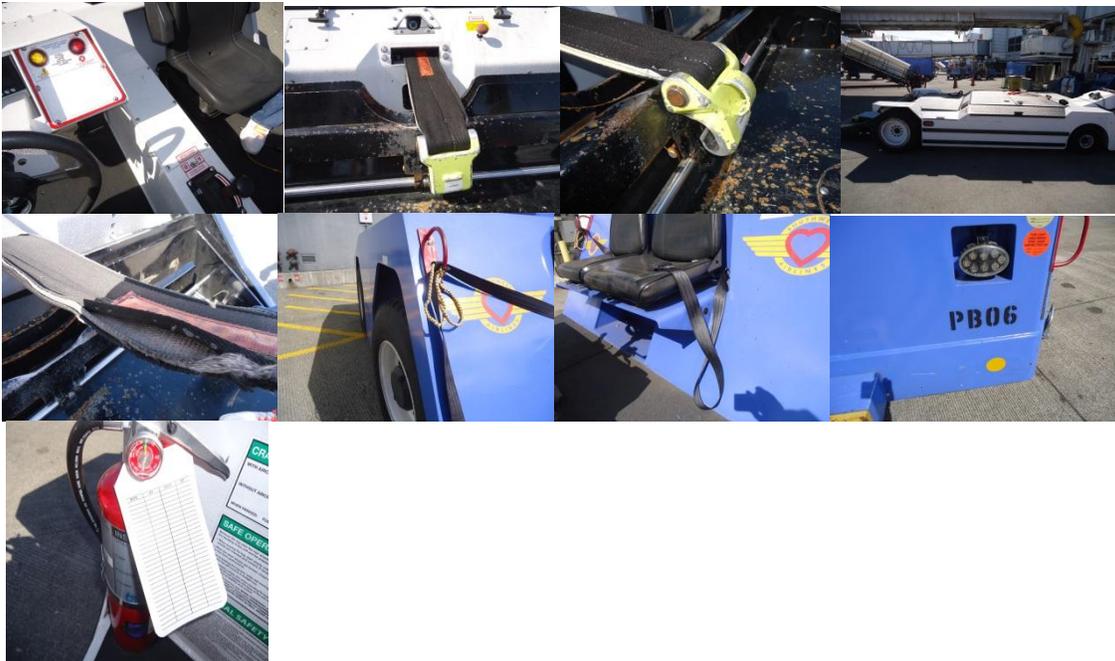
PUSHBACK

1. EPB01-plastic cover on front of bucket is missing; the Operator Daily Checklist is missing on these pushbacks.
2. There are 5 of these pushbacks in SEA and only one has been numbered making it hard to report to GSE. In July Fred Susoeff told Local Rep Shawn that they would put numbers on them.

3. B-8 pushback straps is coming apart, in July Fred Susoeff explained these straps have been compromised.
Remains open from last safety visit 7-15-2015
4. Engine light comes “on” on each one of them, on July 15 2015 West Coast Fred Susoeff was in SEA and explained the red light is about the battery having water in them.
5. PB05 is parked on the ramp and will be used by agents who have not been properly trained on the new pushback. When an aircraft needs an air start--PB05 will be used since it’s difficult to line air start next to the new pushback. Agents expressed concern that this equipment (PB05) has not been on a PM check in a year!
6. Fire Extinguisher monthly inspection tag has no signature or punch hole on card attached
7. PB06-seat belts need to be adjusted, strap is tied to handle

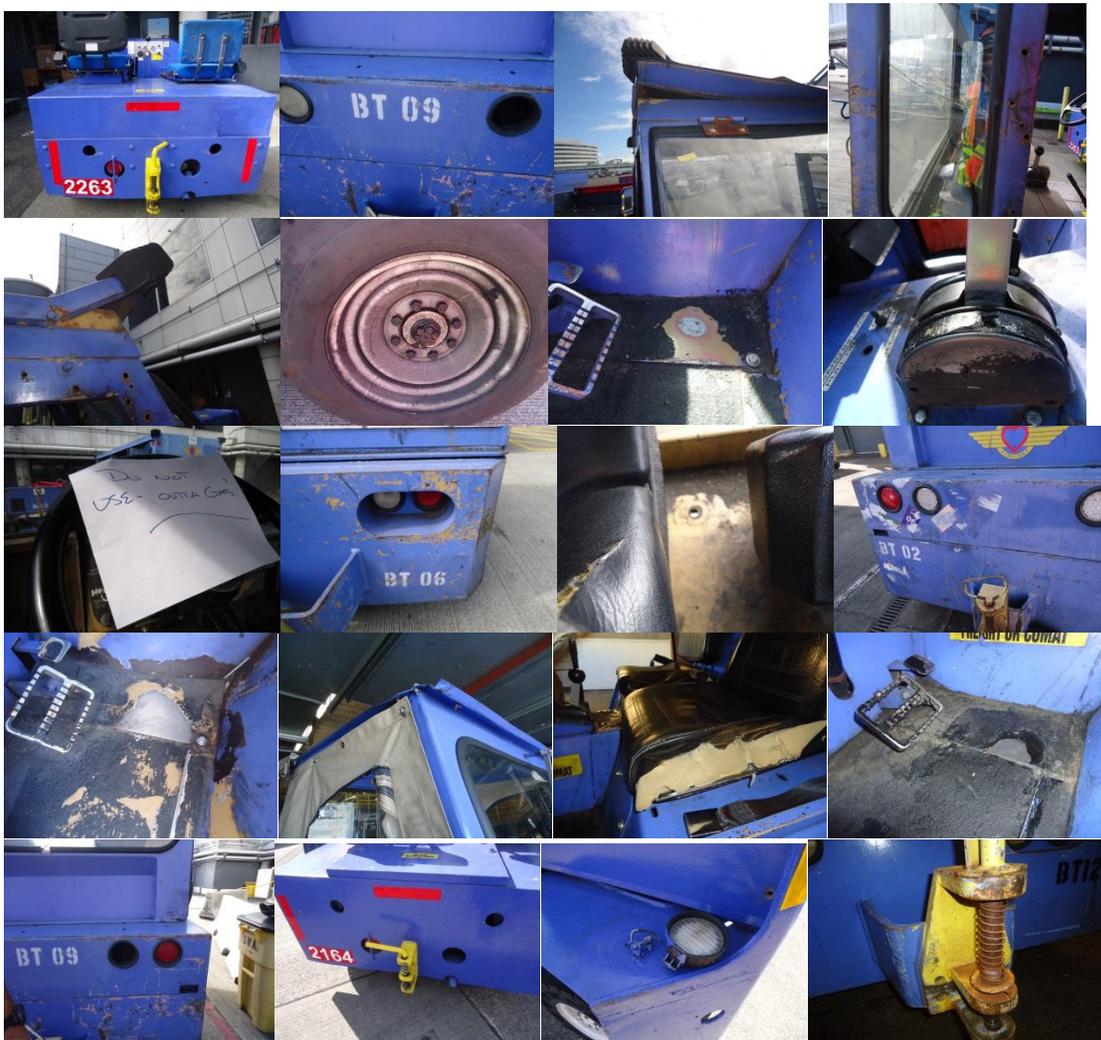
BAGGAGE TUGS

1. BT05-both wheel seals are leaking, anti-skid needs re-applied on gas/driver side and sharp metal edges exposed inside tug on right side. **Remains open from last safety station visit 7-15-2015.**
2. BT06-seat belt fixture is missing on the right side. **Remains an open item since last safety visit 7-15-2015.**This baggage tug had been parked since the 9-12-2015 out of gas, during my visit it had not been refueled.

3. BT08- front right corner rubber bumper is damage and side right glass fixture is broken which was reported in the **last safety station visit 7-15-2015**.

4. BT01-anti-skid needs to be reapplied on gas pedal and at driver's feet. Window on the right side is losing and right rear brake light is out.
5. BT03-corner rubber bumper is missing, E-brake leans to the left, anti-skid tape needs re-applied on gas/brake pedal and seat cover needs replace.

6. BT04-gearshift plate needs replace, grooves are shaved down, anti-skid tape needs reapplied and seat belt doesn't retract properly.
7. BT09-anti-skid on gas pedal needs to be re-applied; the rear tire is worn and needs replaced.

8. BT10-anti-skid needs to be reapplied on gas pedal and at driver's feet. The gear shift light needs replaced.
9. BT-12 driver's seat needs replaced, gear shift light is out and front right tire needs replaced, and back hitch spring is loose.

10. BT2263-back brake light is inoperable and reverse light needs to be installed.
11. BT2164-right head light is broken and reverse head light inoperable.

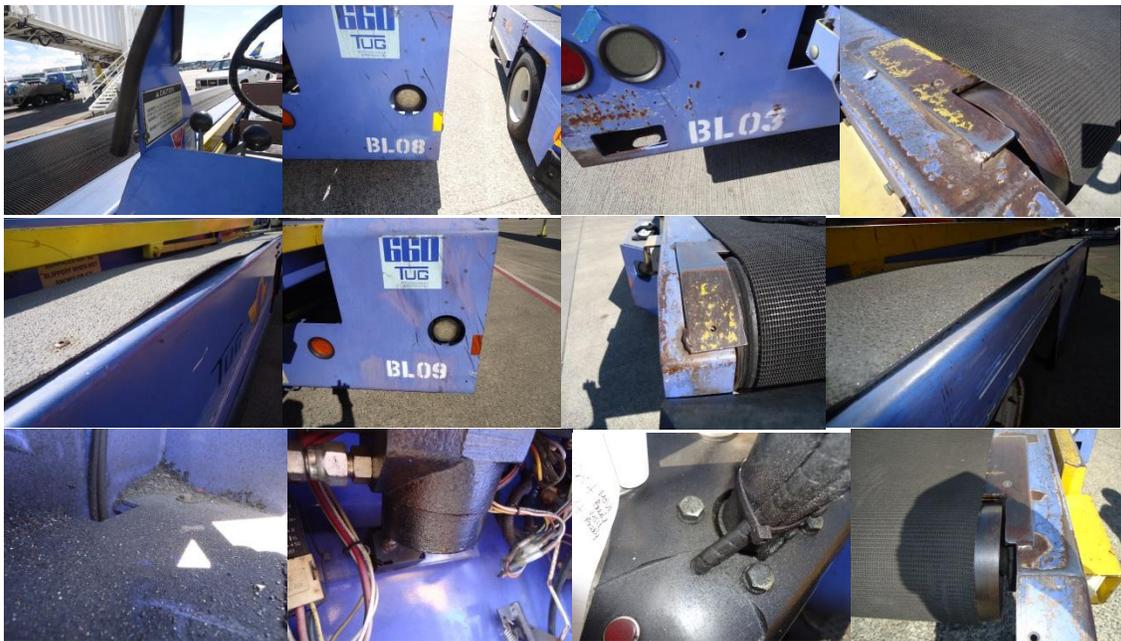
BELTLOADER

1. BL03-steering column has hydraulic fluid on the base leaking down to the ground where driver's feet are located. Saturated residue fluid built up is present and the metal plate has been welded this remains an open item from last safety visit. **Remains Open from last safety visit 7-15-2015**
2. BL01-anti-skid plate is hanging by one bolt that needs to be reattached. **Remains Open from last safety visit 7-15-2015**
3. BL05-anti-skid is bowing; parking brake is rusted unable to adjust. **Remains Open from last safety visit 7-15-2015.**
4. BL04-shark fin needs re-attached, tracking on the belt needs an adjustment and anti-skid tape needs re-applied. **Remains Open from last safety visit 7-15-2015.**
5. BL08-shark fin needs re-attached. **Remains Open from last safety visit 7-15-2015.**

6. BL09-belt tracking system needs to be adjusted, anti-skid plate is bowing and metal plate has been welded down.

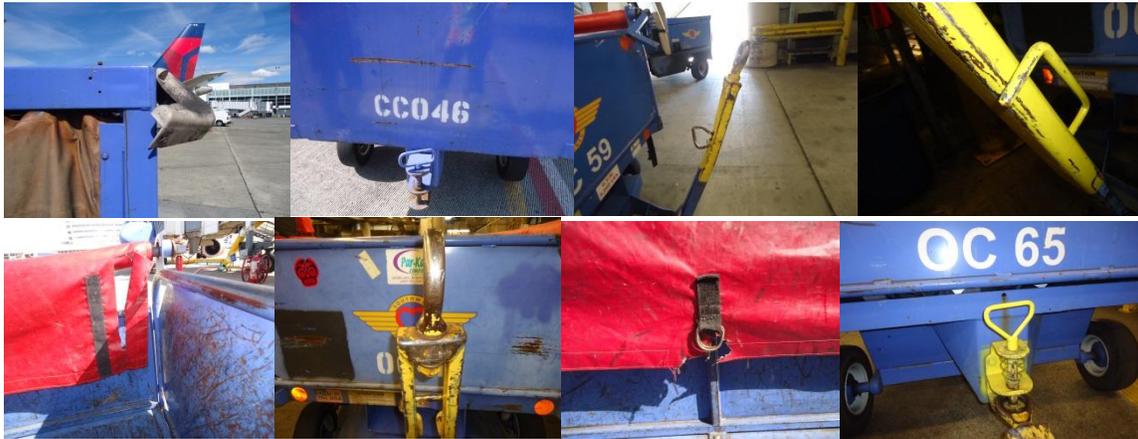
BAGGAGE CARTS

These are just some of the examples looked at during my Safety Inspection

Brake Bars on several carts found that the tongue drops to the ground. Agents have been informed that it's costly to repair. The employees have expressed their concern that leadership is putting cost before the employee. The brake bar drops on the agents foot, who has reported to leadership and nothing gets fixed.

1. OC025- brake bar handle is broken sharp metal exposed and back hitch spring is loose.
2. OC024-back hitch spring is loose.
3. OC031-brake bar is loose and back hitch spring is loose.

4. OC023-back hitch spring is loose.
5. OC24-tongue falls to ground, needs spring hitch
6. OC30-front end is loose the (5th wheel.)
7. OC31 tarp straps are worn

8. OC38-back hitch spring is loose and the front end loose (5th wheel.)
9. OC39-hitch handle is bent and back hitch spring is loose
10. OC40-tarp is damage and back hitch spring is loose and eyelet needs to be replaced.

11. OC41-eye lid spins around all the way around and back cart panel is damaged.
12. OC43-tarp is damaged, back hitch spring is loose and sharp metal edges exposed front railing.

13. OC44-brake bar needs adjusted, while setting brakes it pulls to left to right.
14. OC51-locking pin on brake bar is bent.
15. OC54back hitch spring is loose and eyelet needs to be replaced.

16. OC60-brake bar is bent.
17. OC66-tarp is damage, brake bar needs to be adjusted and back hitch spring is loose.
18. OC65-tarp is damage and back hitch spring is loose.

19. OC68-tarp strap is missing and are damage and eyelid spins around that connects to the baggage tug or another cart.

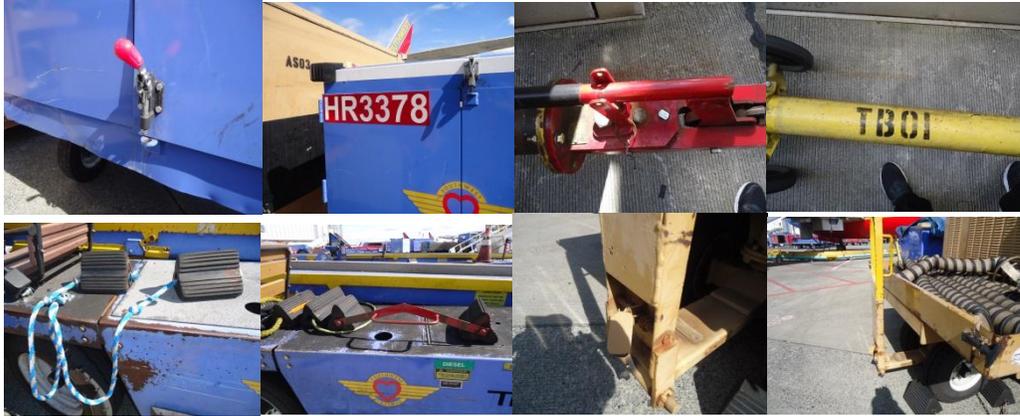
HR CARTS/TOW BAR/CHOCKS

1. Safety mechanism on brake bar is bent needs to be bent back into place. **Remains Open from last safety visit 7-15-2015**
2. TB01- shear bolt doesn't move freely (**These are supposed to move to prevent shear bolt breaking during push.**)
3. TB03-shear bolt doesn't move freely
4. HR 3378 door locks are bent, doors don't shut properly. **Remains Open from last safety visit 7-15-2015.**
5. HR037-bent door locks on rear door, will not shut properly.
6. LT01-flags need to be replaced, signal light on driver side in front needs to be reattached. Seat cover on driver side needs to be replaced. **Remains Open from last safety visit 7-15-2015**
7. LC01 both blue water hoses are worn and need to be replaced
